MANDATORY**SEL-24-10****TITLE**

ELECTRICAL POWER - MASTER CONTROL UNIT S/N INSPECTION AND REPLACEMENT OF WIRE HARNESS

March 12, 2019

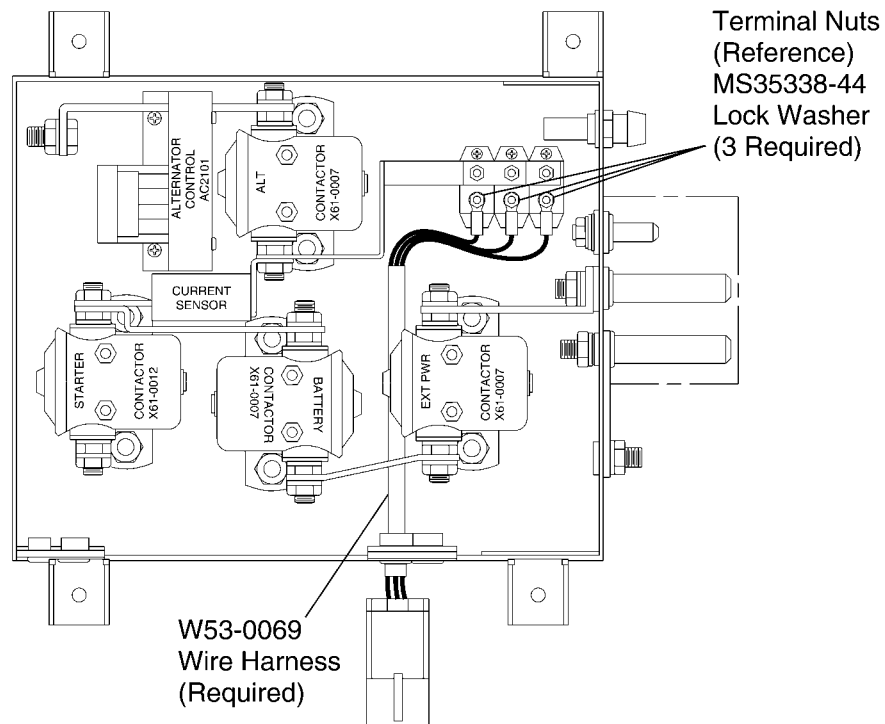
Figure 1. MCU Wire Harness (Sheet 1)

Some S3100-594 Master Control Units (MCU) have been found with improper terminal crimps on the electrical connector for the W53-0069 Wire Harness. A terminal crimp that is not correct can have a loose connection which can cause electrical arcing that can lead to an electrical fire and/or complete loss of electrical power.

4. Remove the front cover (and cooling shield for T206H airplanes) from the MCU.
5. (Refer to Figure 1.) Replace the W53-0069 Wire Harness in the MCU as follows:

- A. Disconnect the electrical connector for the W53-0069 Wire Harness.
 - B. Remove the three terminal nuts and MS35338-44 Lock Washers; keep the nuts and discard the lock washers.

- C. Remove the W53-0069 Wire Harness keeping attention to the routing of the wires inside the J-Box.
 - (1) Make the removed W53-0069 Wire Harness unusable by cutting the connectors off and discarding.

- D. Install the new W53-0069 Wire Harness with the wires routing the same as the removed wire harness.
 - E. Install the three terminals, MS35338-44 Lock Washers, and kept nuts; torque the nuts to 25 Inch-Pounds.

- F. Connect the electrical connector for the W53-0069 Wire Harness.
